## QUARTZELEC WHITE PAPER

Damaged generator rotors: the economic and logistical benefits of repair over scrappage. New advances in repair techniques and stress analysis extend the feasibility of a repair further than traditionally thought.

# CASE STUDY

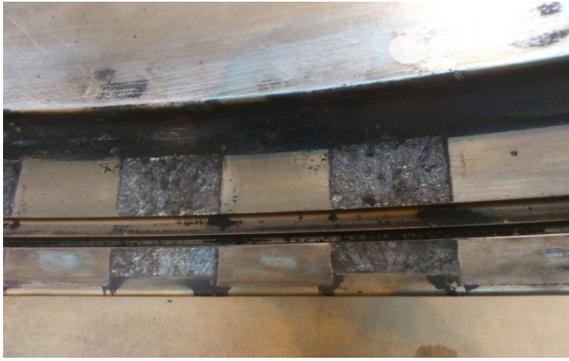
Figure 2 & Figure 3 (overleaf) clearly show severe damage caused by high currents flowing in the damper circuit during the motoring incident. When the rotor is stationary, there are no centrifugal forces to load the slot content against the rotor to cause full contact between the ends of the rotor slot wedges and the end winding retaining rings. Full contact between the slot wedge flanks and wedge slot flanks also becomes intermittent.

The majority of induced currents flow through the aluminum wedges and rotor body surface, causing substantial heat to be produced when a high resistance joint occurs between two damper circuit components. This explains the severe arcing damage on wedge tips, flanks and retaining rings. Similar damage was found in every slot dovetail.

**Figure 2.** Molten retaining ring fit area

- Both retaining rings showed evidence of severe arcing damage and were scrapped.
- Existing retaining rings were reverse engineered. New retaining rings were manufactured from 18/18 material to ASTM A289.

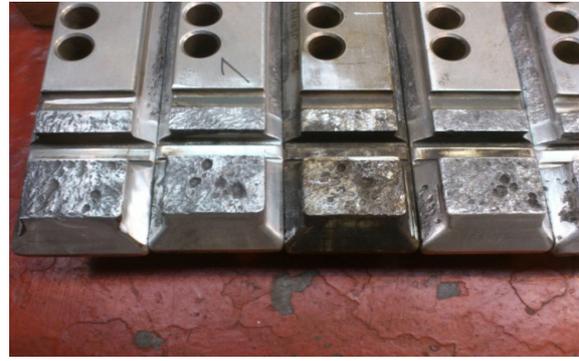
**Figure 3.** Molten wedges

- All aluminium wedges showed evidence of severe arcing damage along their entire length and were deemed unfit for use.
- Because the rotor slot dovetails were opened to remove arcing damage, new wedges were required.
- Existing aluminium wedges were reverse engineered.
- New wedges were manufactured to incorporate new modified shape and original vent hole configuration.

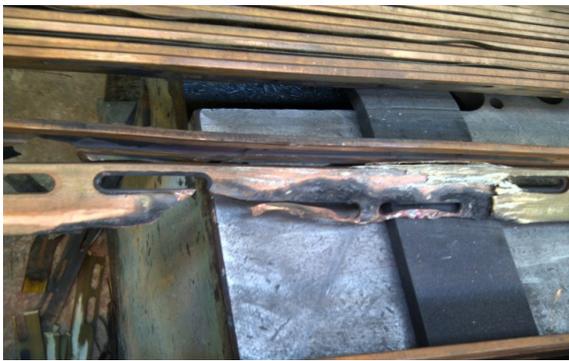
In addition, almost 20% of the copper winding on the rotor had either been melted away or suffered severe distortion. See Figure 4 & Figure 5 below.

**Figure 4.** Molten copper from slot 24

- The rotor copper was thoroughly inspected to identify damaged turns.
- Hardness tests were conducted to review the condition of coils affected by high temperatures.
- Collapsed copper corners were found on every top turn, prompting the decision to replace every coil.
- Approximately 20% of the winding was deemed unsuitable for re-use.
- New copper turns were manufactured using silver bearing copper, drawn to incorporate the contraflow cooling system.

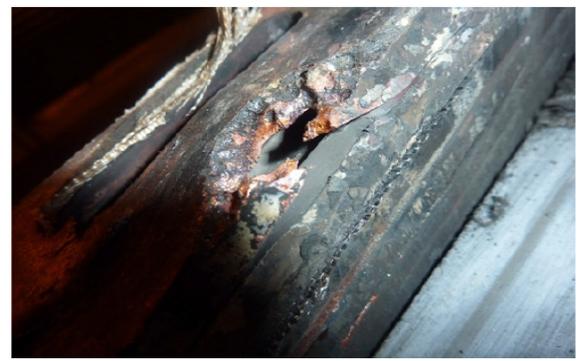
**Figure 5.** Molten copper from slot 11

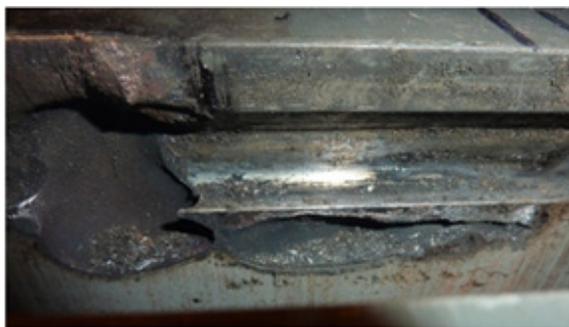
Later investigation confirmed the presence of a double earth fault, resulting in severe arcing damage. Two deep excavations (250mm and 300mm axially, up to 20mm deep) were found within two of the forging slots where material had vaporized at the site of the earth faults. It is believed that an earth fault had occurred during attempts to run the generator after the motoring incident. See Figure 6 & Figure 7 below.

**Figure 6.** Molten tooth in slot 11

- The locations of the earth fault on the rotor body were dressed out.
- Metallographic replicas to make sure that the heat affected zone was completely removed.
- Additional hardness tests were conducted in multiple locations around the damaged area.
- A weld repair to the rotor body was subsequently carried out (See Figure 8 overleaf).

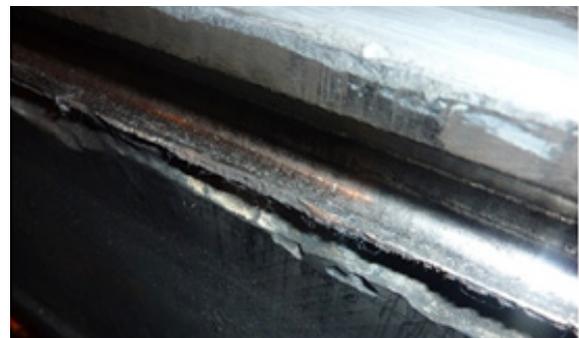
**Figure 7.** Molten tooth in slot 24

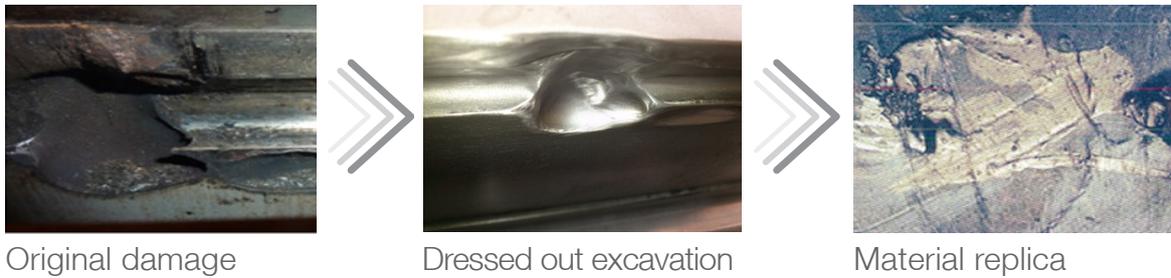
**Figure 8.** Earth fault location recovery process

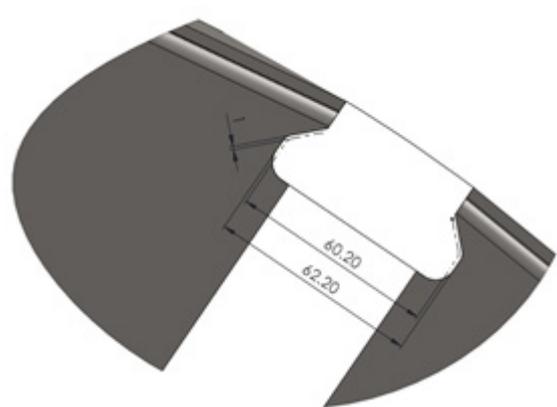
To determine if machining the profile to remove the damaged material was a viable option, an FEA study was undertaken of the original profile and of the new profile, see Figure 10.

**Figure 10.** New profile dimensions and the old in chain dotted

- Severe arcing damage was confirmed in all rotor dovetails.
- The depth of the most severe damage was measured.
- It was identified that it was necessary to open every slot by 1mm in order to remove all damage.
- Stress analysis of the rotor teeth was conducted to prove the mechanical integrity of the new dovetail and wedge design (see Figure 8 overleaf).

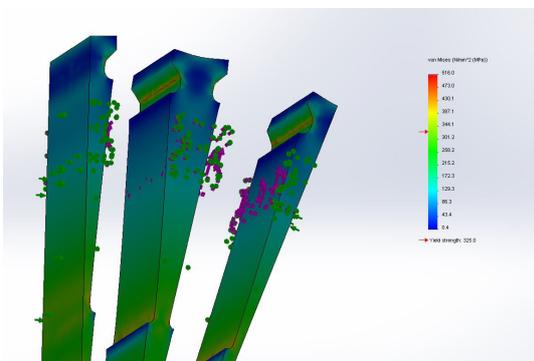
The Von Mises stress between the two profiles changes by only 8.7% for the increase in width.

**Figure 14.** Stress pattern, original slot profile

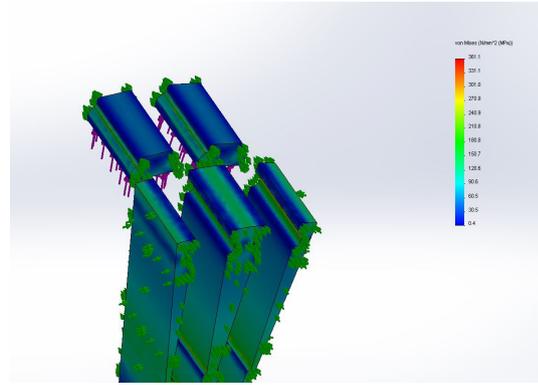
**Figure 17.** Stress pattern

This also confirmed that the bending stress on the aluminium wedge remained within a reasonable level, despite the slight increase in span.

All the simulations confirm that an increase in profile results in a minor increase in stress, but would not be detrimental to the rotor stress, or wedge, even at overspeed.

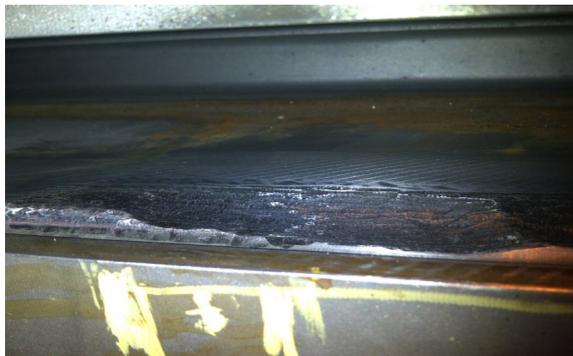
**Figure 19.** Slot 24 ready for weld repair

Once the excavations had been prepared by the removal of heat-affected areas – confirmed by performing a set of material replicas and additional hardness tests – preparation for TIG welding commenced. The rotor forging was preheated to increase the strength of the weld and provide finer weld structure by full martensite transformation using highly accurate temperatures. The welding was then carried

out in accordance with internal processes at previously agreed parameters by highly experienced welders specialising in this procedure. The welding locations were then carefully dressed to allow NDT inspection. Both magnetic particle and ultrasonic tests were carried out by a specialist NDT technician with over 35 years experience to confirm effective fusion between materials. Finally, both weld locations were hand-polished and the forging stress relieved in accordance with company internal specifications.

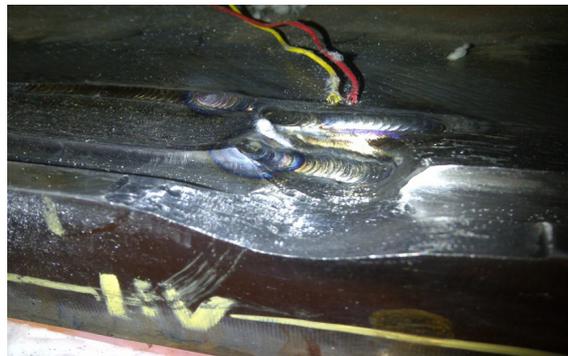
**Figure 20.** Slot 11 ready for weld repair
