QUARTZELEC TECHNICAL BULLETIN

Industry has moved to adopting 18/18 as its latest 'standard' steel for retaining rings. These high quality steels are fully stainless to prevent SCC, but are not fully corrosion resistant and Quartzelec have found incidents where corrosion has proven to cause critical damage. This article discusses how smart engineering studies and considered decisions could salvage retaining rings which otherwise would be scrapped.

TO RECOVER CORRODED RETAINING RINGS

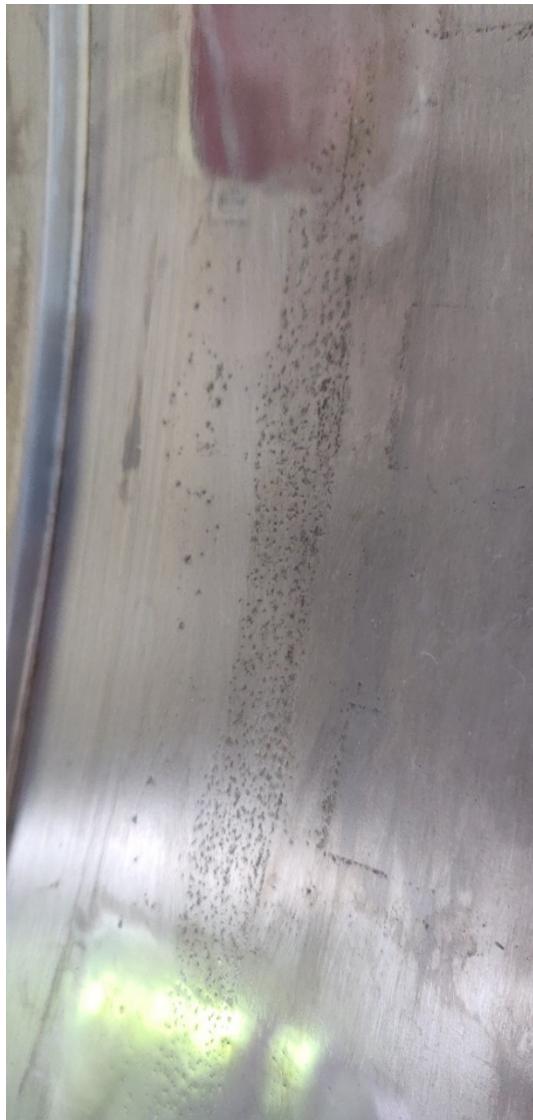
On one particular and very recent occasion during the routine outage of a 200MW generator, a simple visual and (subsequent) dye penetrant inspection located a high level of pitting mapping the position of mating components in the retaining ring bore, inboard of the centring ring and at the nose in the axial locking groove and around the damper segments. Local polishing appeared to make the defects more prominent indicating occluded pitting.

A more detailed NDT including Replica and Ultraviolet dye penetrant test were performed, and the report confirmed that the indications were formed from corrosion rather than electrical arcing.

Figure 2. Shrink fit pitting

Moisture, if present, is drawn into crevices, often by being centrifuged outward by the rotation of the shaft and the moisture becomes entrapped or drawn into gaps under capillary action. When deprived of oxygen, stainless steel lacks the ability to re-form a passivating film of chromium oxide and crevice corrosion occurs.

On this particular occasion, we concluded that the rings would be safe after machining and we instructed the machinist to carefully remove the corroded material.

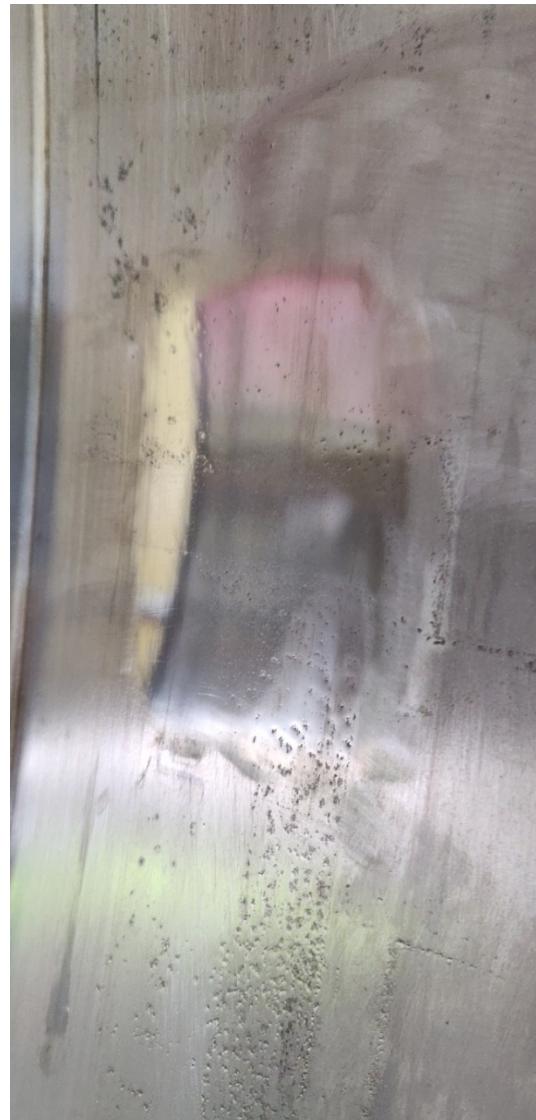
Figure 3. Shrink fit pitting after polishing

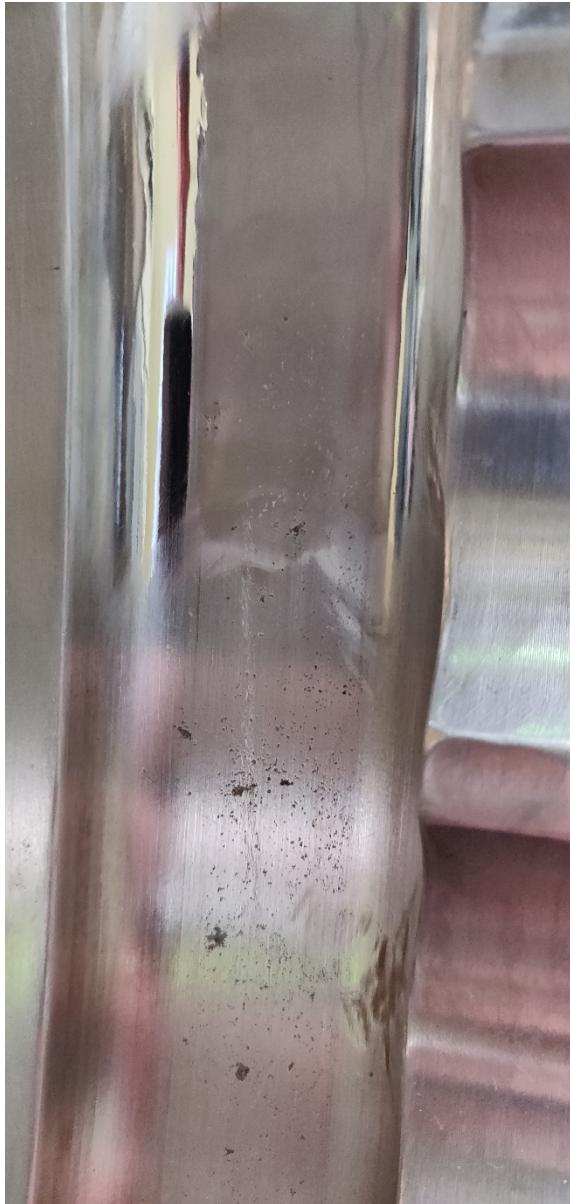
Figure 4. RR groove pitting

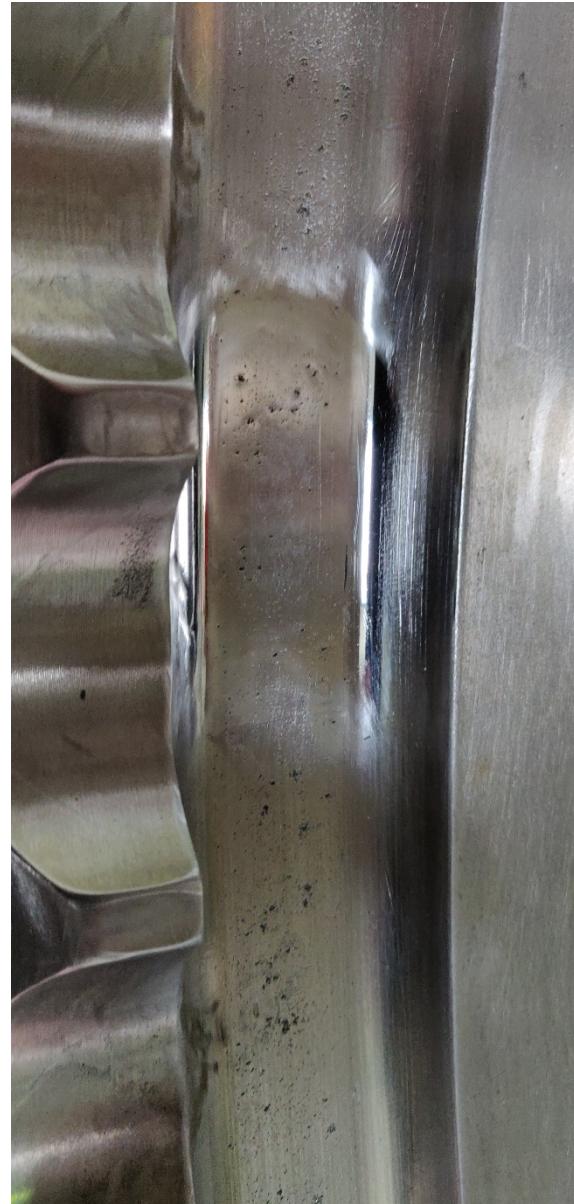
Figure 5. RR groove pitting after polishing

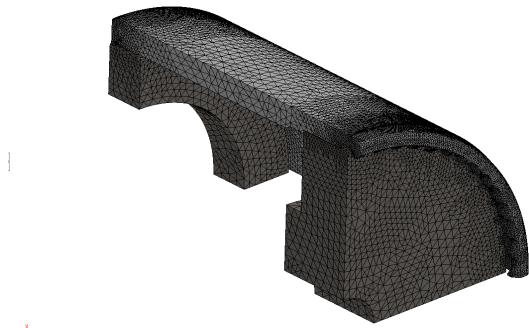
For the 200MW generator project, the existing retaining ring stresses and interference fit were calculated at standstill and overspeed using thin cylinder theory and Finite Element Analysis. The calculations were repeated to simulate the machining needed to radially remove material from the retaining ring to rotor interference fit diameter, bore diameter and inboard groove to remove the defects found.

Model name: QD200A1 - FEA assembly_rings_stress
Study name: Original (standstill) OnPartR
Mesh type: Solid Mesh

Figure 6. Mesh details
