# 2.75MW Seawater Cooling Pump Motor Emergency Motor Overhaul & Repair

POWER GENERATION | MELAKA, MALAYSIA

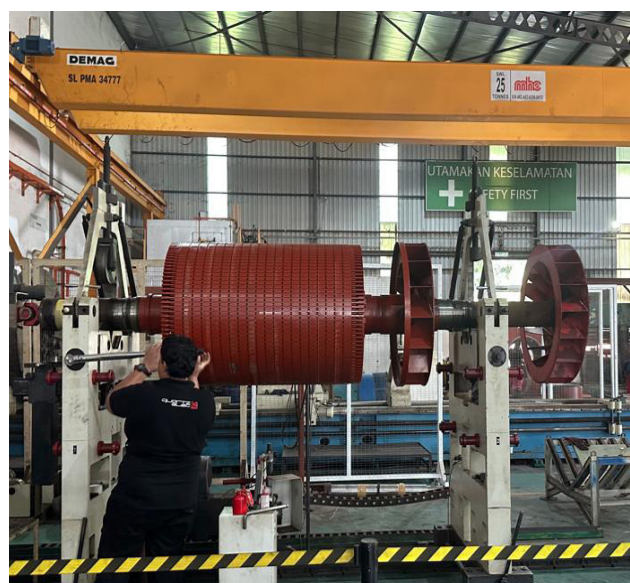
Quartzelec responded immediately to the emergency repair requirement, prioritising the overhaul of the critical 2.75MW seawater cooling pump motor to help restore plant availability and minimise generation losses. The motor was transferred to the Selangor based workshop, where engineers carried out a complete strip-down and detailed inspection to assess its condition and identify the repairs required. The overhaul included comprehensive testing, component assessment, replacement of critical parts, installation of new SKF bearings, dry ice cleaning of both the stator and rotor, rotor balancing, reassembly, and final inspection checks prior to returning the motor to service.

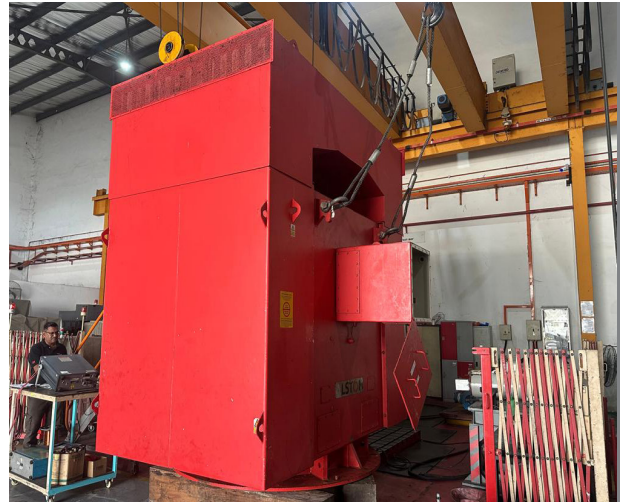
Where technically appropriate, selected components were replaced rather than refurbished to reduce repair time and accelerate the overhaul programme. The team also worked extended hours throughout the project to maintain progress and achieve the shortest possible turnaround. By combining rapid mobilisation, specialist repair capabilities, advanced cleaning techniques, precision balancing, and experienced engineering judgement, Quartzelec delivered a safe, reliable, right-first-time overhaul solution that enabled the customer to restore seawater cooling capacity and improve overall plant operational readiness.
