## QUARTZELEC WHITE PAPER

Damaged generator rotors: the economic and logistical benefits of repair over scrappage. New advances in repair techniques and stress analysis extend the feasibility of a repair further than traditionally thought.

# CASE STUDY

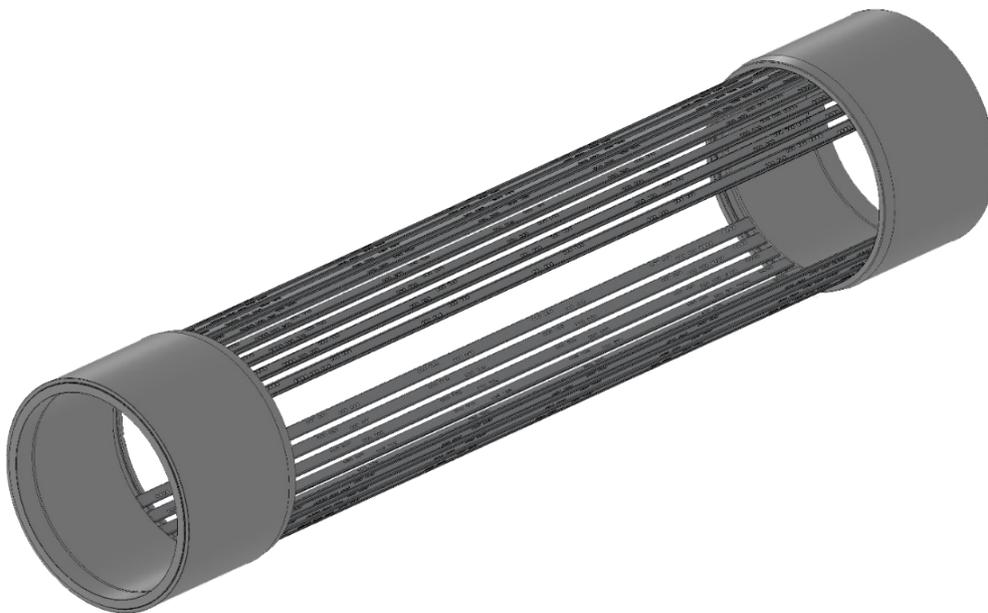
The situation changes dramatically if the generator rotor is running at low speed or standstill and the main circuit breaker has been inadvertently closed. Under such conditions, the generator attempts to run as a squirrel-cage motor, using a damper circuit (Figure 1). High currents flowing through the stator winding induce a 50Hz current flowing in the rotor components. Due to lack of centrifugal force, high resistance is created between squirrel-cage components, generating excessive heat. The rotor will try to accelerate, but the presence of rectification diodes within the excitation system will allow only half cycle current to flow through the damper circuit, successfully reducing the rotor speed. Bitter experience shows that generators exposed to this condition can be permanently damaged in a matter of seconds.

**Figure 1.** Rotor damper circuit made from wedges and retaining ring

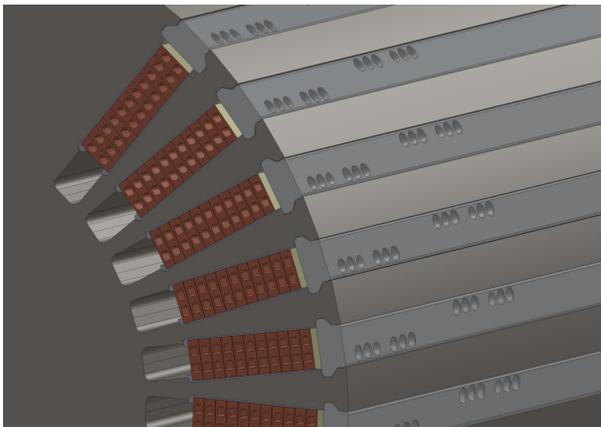
The rotor is machined from a low alloy steel Ni, Cr, M having 0.2% proof stress of 600-700MPa. The rotor has longitudinal slots to give the correct location for the copper stack to be positioned as Figure 9 below.

The forces generated by rotation are restrained against radial movement by the aluminium wedge that locates in the dovetail profile of each rotor slot, see Figure 9.

**Figure 9.** Rotor slot content

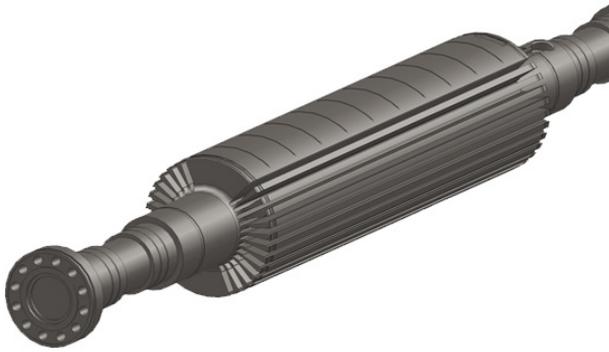
The rotor slots are distributed symmetrically about the rotor's Z axis – a feature used to reduce the FEA model down to two slots. The slot was also loaded uniformly along the length of the wedge due to the mass of the copper and the aluminium wedge acting on the dovetail profile. This enabled a 100mm section to be taken to represent the rotor length, see Figure 11 & Figure 12.

**Figure 11.** Rotor forging – general view

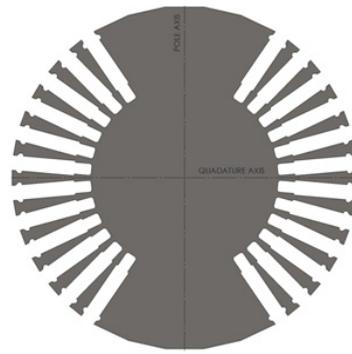
**Figure 12.** Rotor forging cross section through rotor body

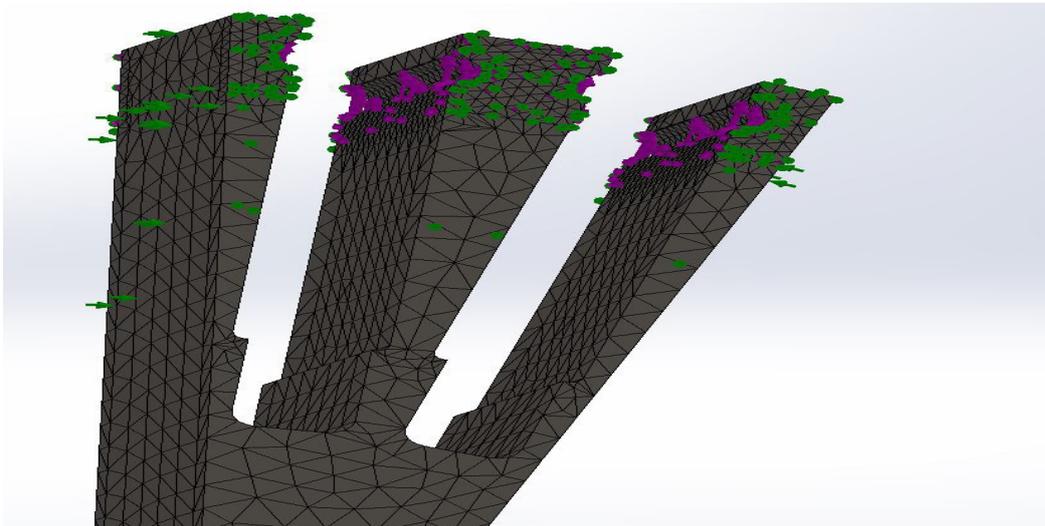
The model was restrained against movement in the Z axis (axis of rotation) on the faces – and normal to the radial faces – leaving the section free to move in the radial directions.

**Figure 13.** Restraints and applied load to profile flanks

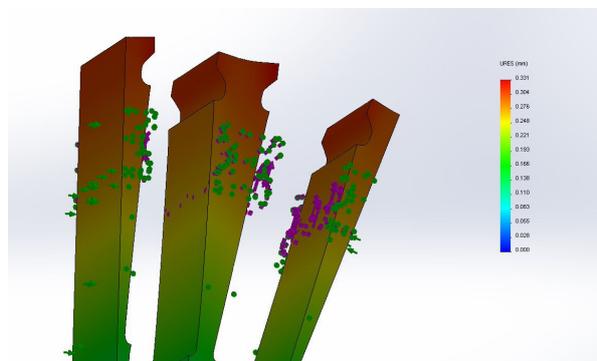
**Figure 15.** Displacement pattern, original slot profile

Whilst not the deciding factor, the predicted stress for the groove was higher than expected, for both profiles. To check that the FEA model had not been over simplified, an additional simulation was conducted with the wedge included in the model and loaded against the slot flank profile.

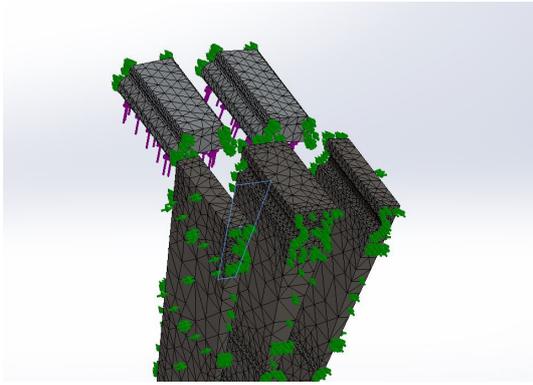
The meshing and restraints used the same symmetry principle as for the simple FEA model, with the contacting flanks of the wedge mated to the rotor slot profile for a no penetration contact. This contact allows for sliding motion between the two faces and more realistic simulation; NB the figures overleaf show the model in an exploded view.

**Figure 16.** Medium mesh with wedges in exploded view

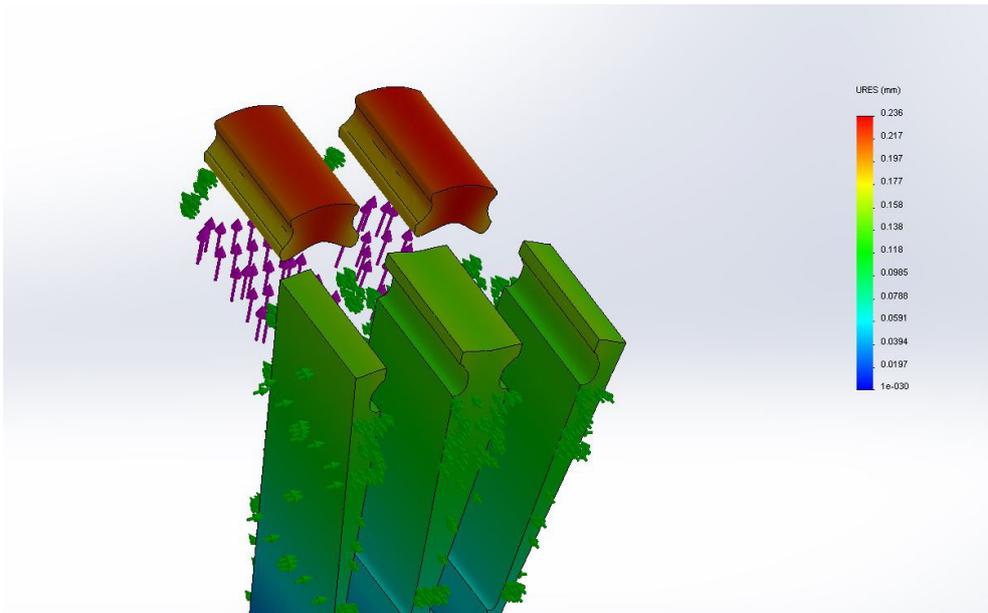
**Figure 18.** Displacement pattern

This also confirmed that the bending stress on the aluminium wedge remained within a reasonable level, despite the slight increase in span.
