Turbo Generator Major Inspection

Quartzelec disassemble 12.5kW AEI turbo generator for their client, to inspect, test, and perform necessary repairs, ensuring continued reliable operation

POWER GENERATION | SOUTH EAST, UK

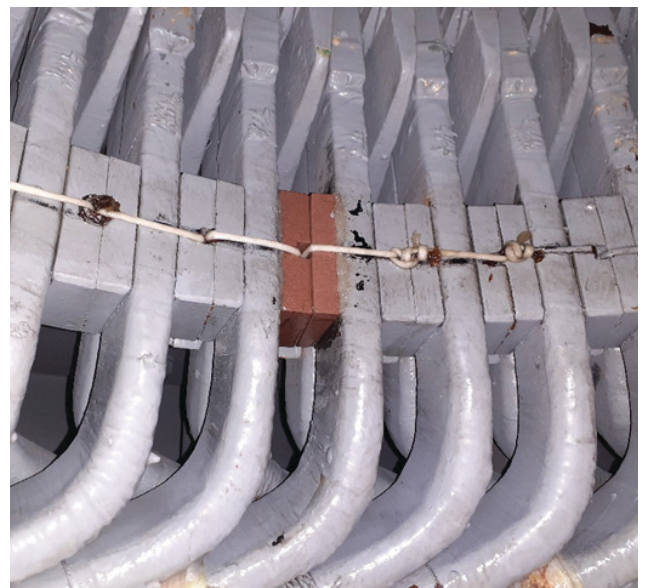
On-site, Quartzelec carried out cryogenic cleaning of the stator and performed a detailed stator winding inspection which revealed early signs

of Partial Discharge (PD) activity in one slot mouth block, which required rectification to prolong the winding's lifespan. Repairs were made by removing the adjacent slot mouth blocks, cleaning back through the top varnish and paint to expose the stress grading tape, which was then reinstated with semiconductive paints.

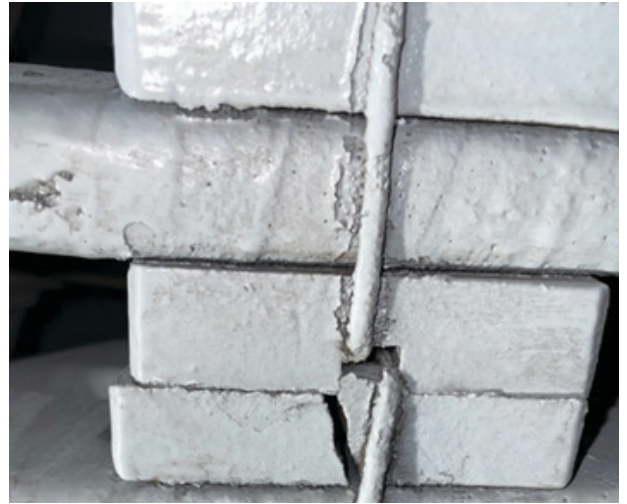
Additionally, a cracked slot mouth block was found and replaced with a new block, manufactured at the Quartzcoil Fibreglass Workshop, part of the Quartzelec group of companies, and was installed on-site.

Damage to the stator end winding bracing cord and glass tapes was also identified, causing movement in the top and bottom stator bars, which were repaired to restore the stator bracing to an acceptable standard.
